[REDACTED]

Zephyrhills, FL, 33542

February 20th, 2024

Inspected *by* Md Uddin

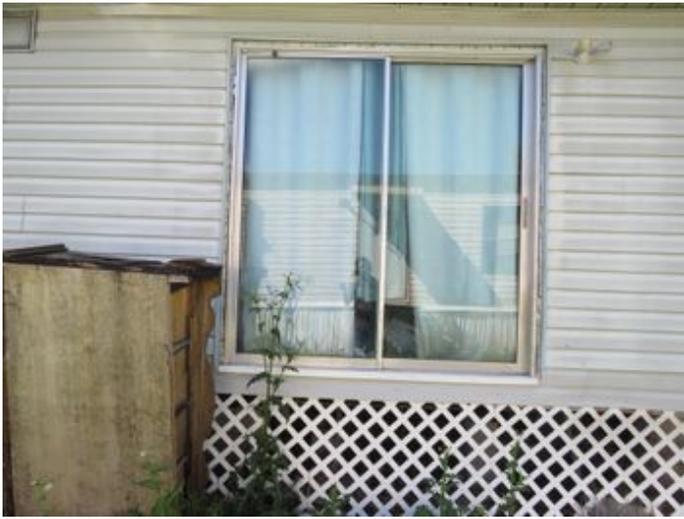
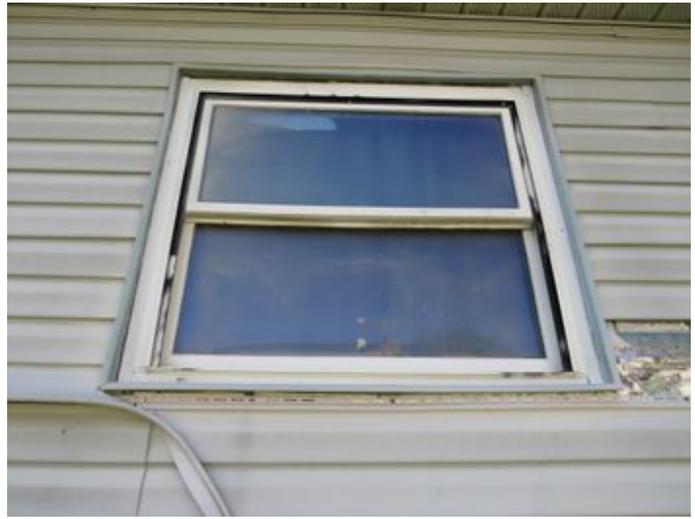
2.3 · DOORS & WINDOWS

Overall condition of the doors and windows are satisfactory. Deficiencies/ damage/ wood rot and termite infestations observed at the indicated area. Repair required

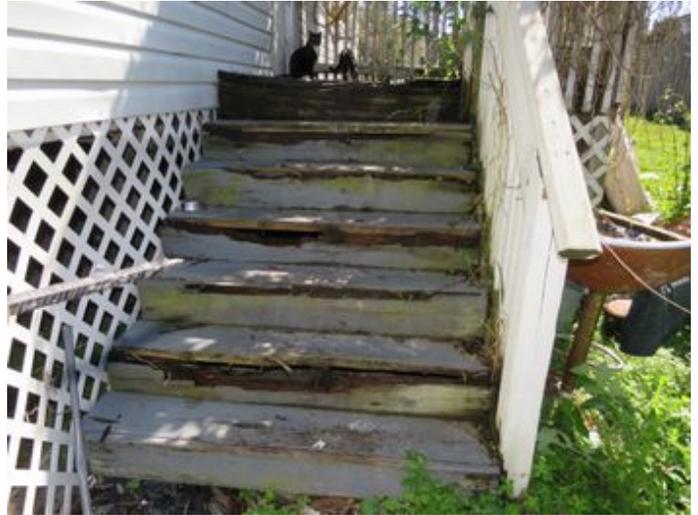
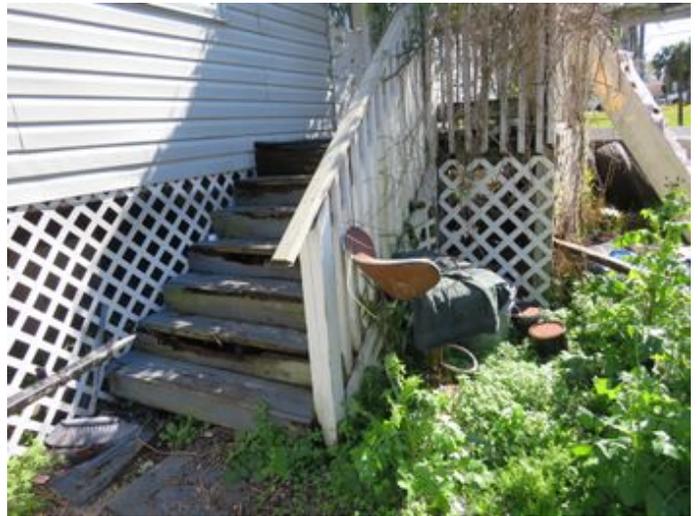
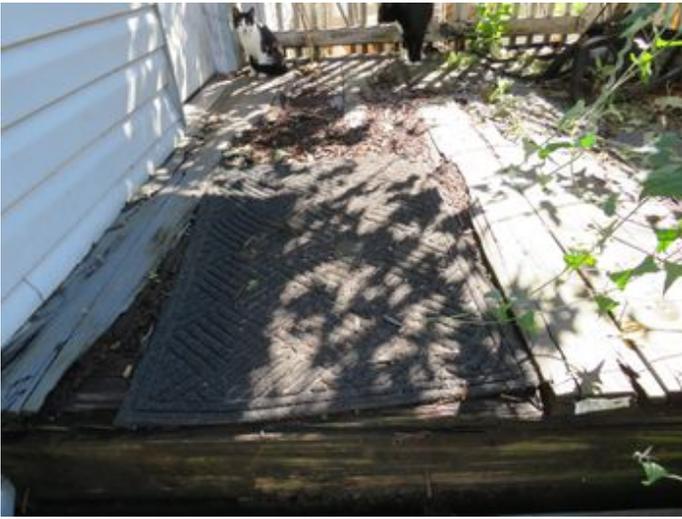
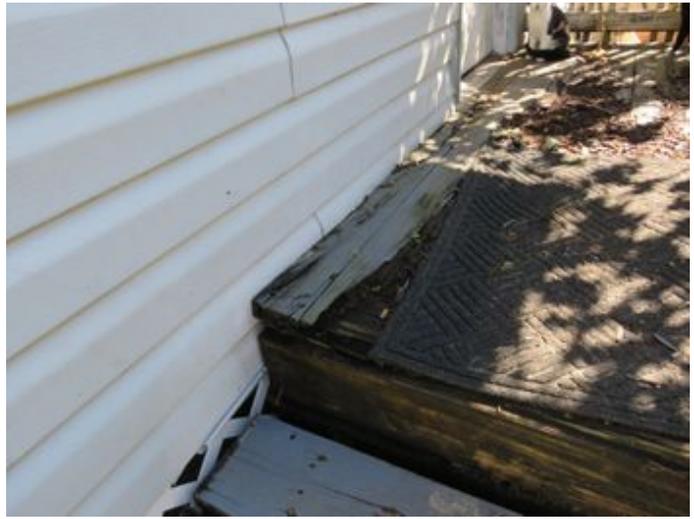
2.4 · DECK

Deck is broken/damaged. Replacement required

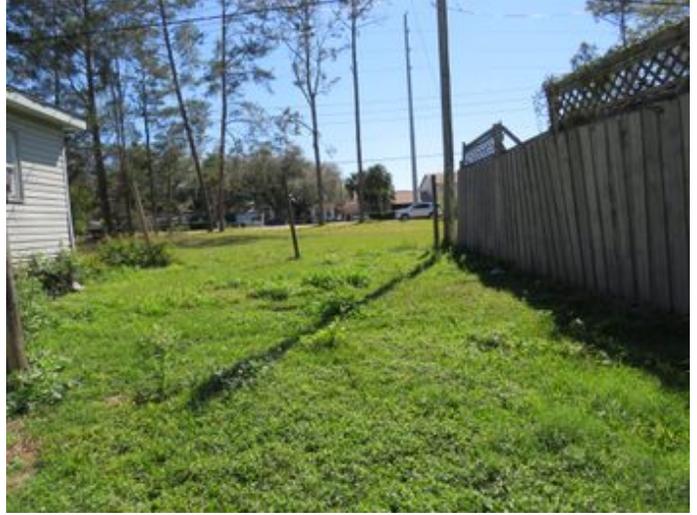
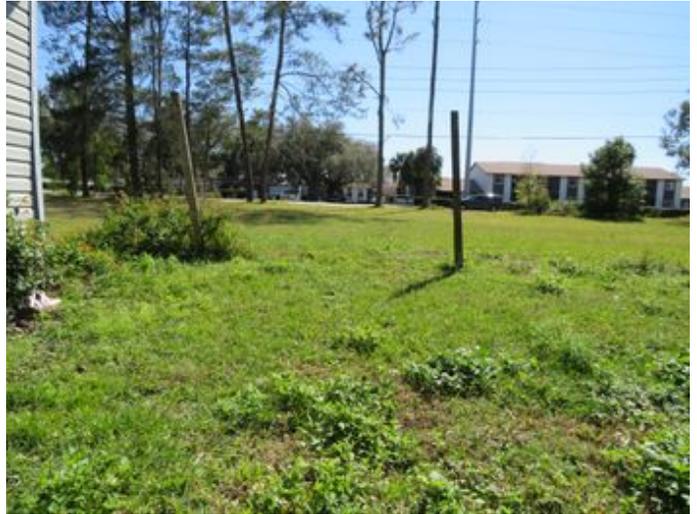
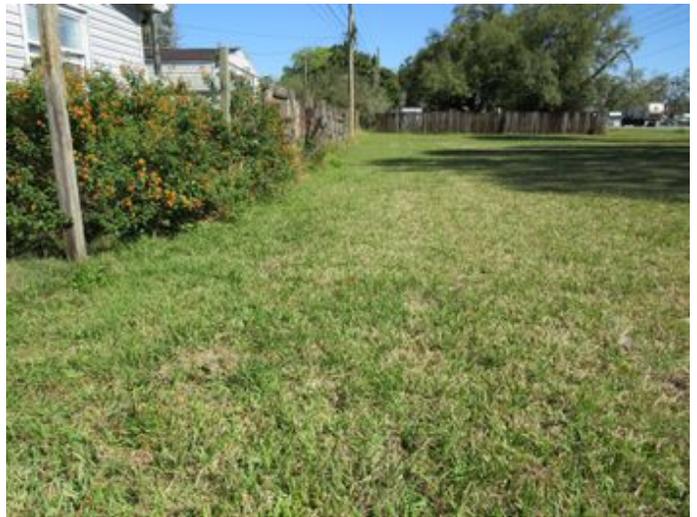
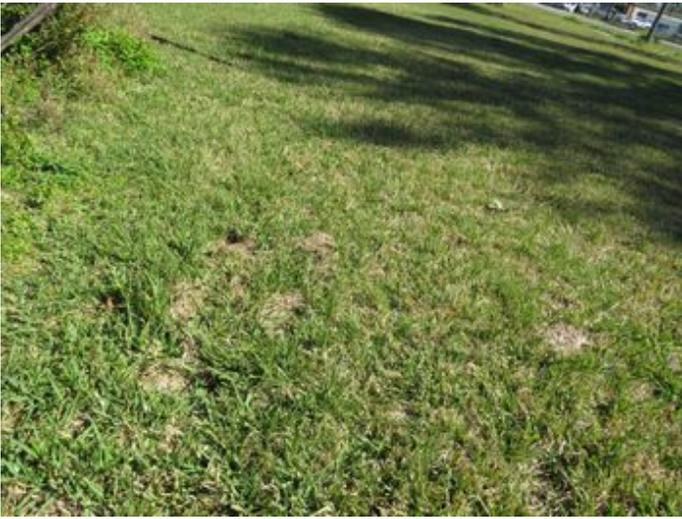
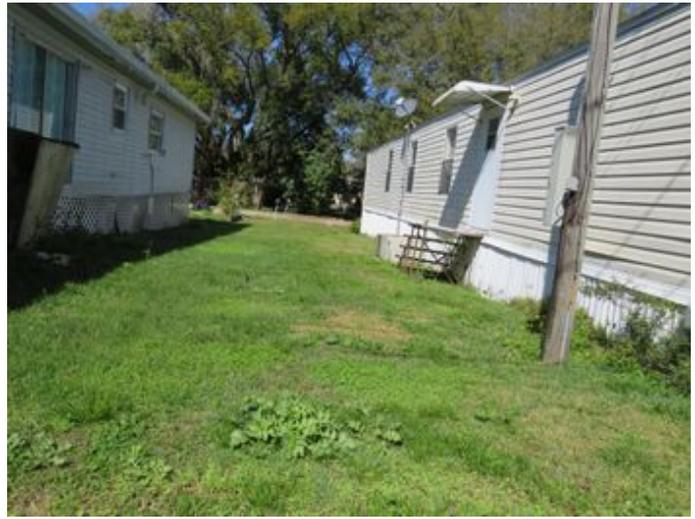
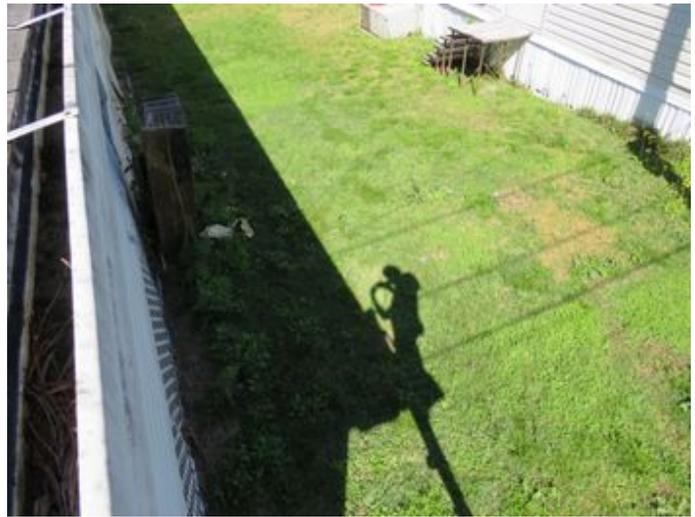
2.6 · FLAT & LEVEL PAD

The residence is situated on a flat level pad, which would typically not need a geological evaluation. However, we do not have the authority of a geologist and you may wish to have a site evaluation. Due to the rain/other causes, some soil washed away/missing from the indicated areas. Sand/soil fill recommended

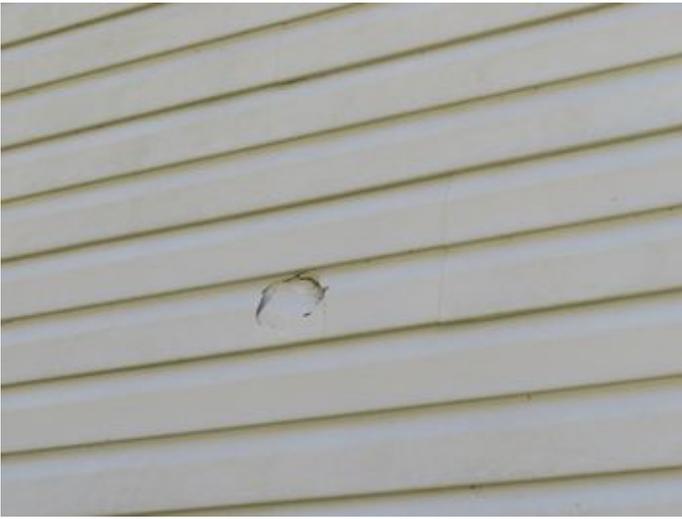
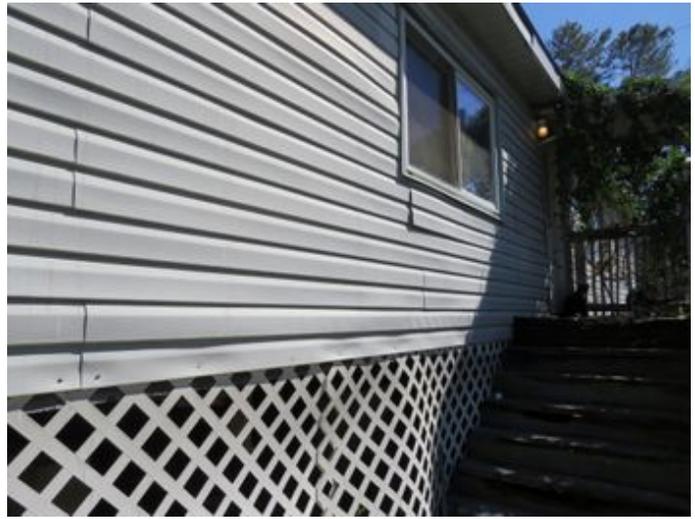
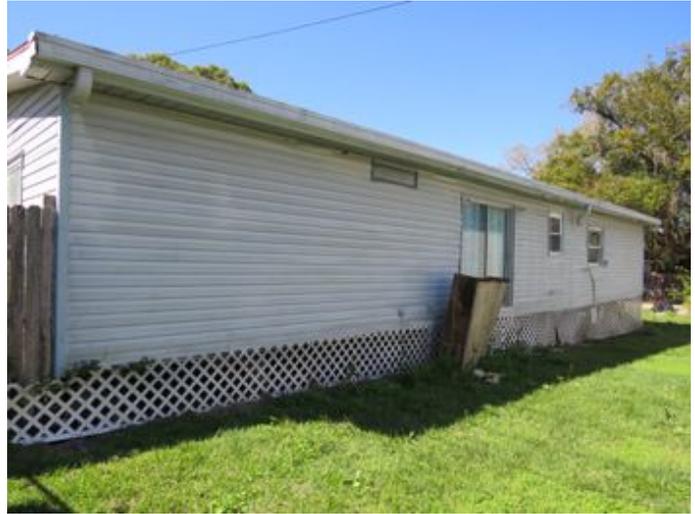
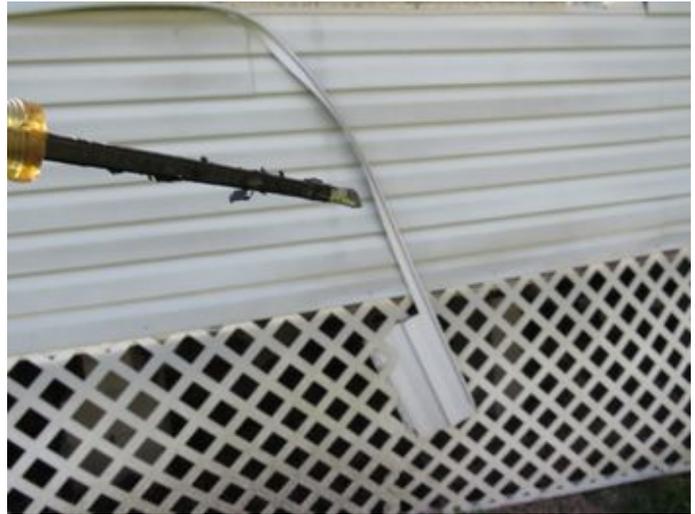
2.10 · HOUSE WALL FINISH TYPE

The house walls finished with vinyl siding. Indicated areas observed minor cracks. Repair recommended

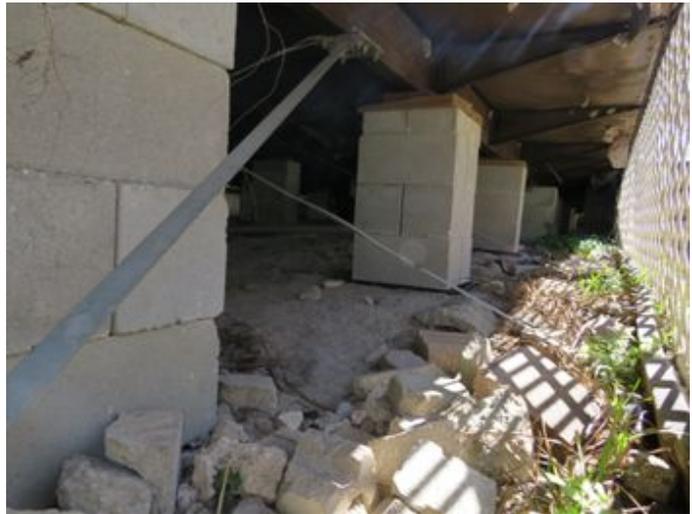
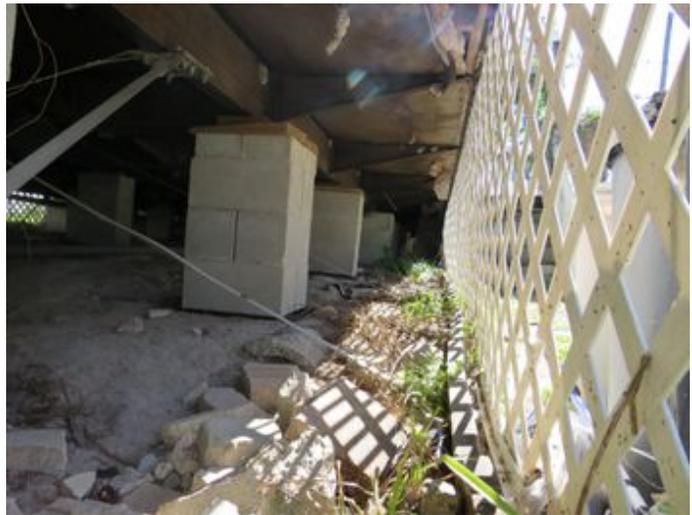
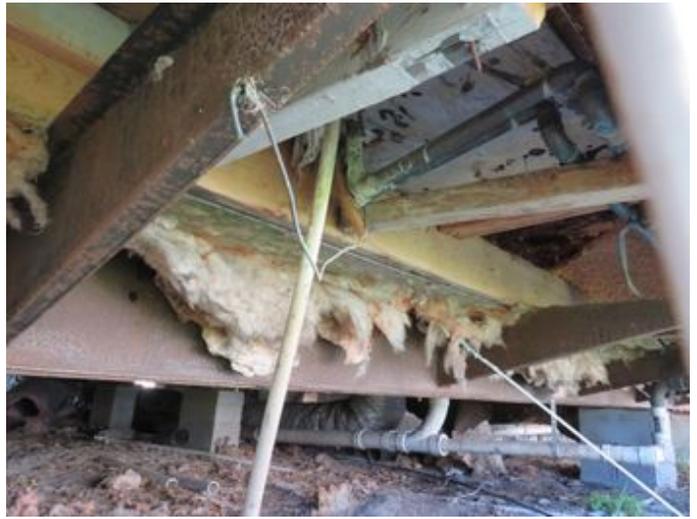
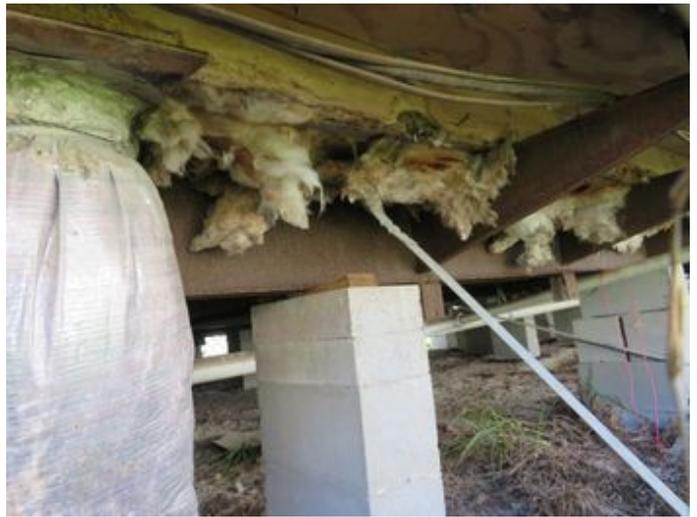
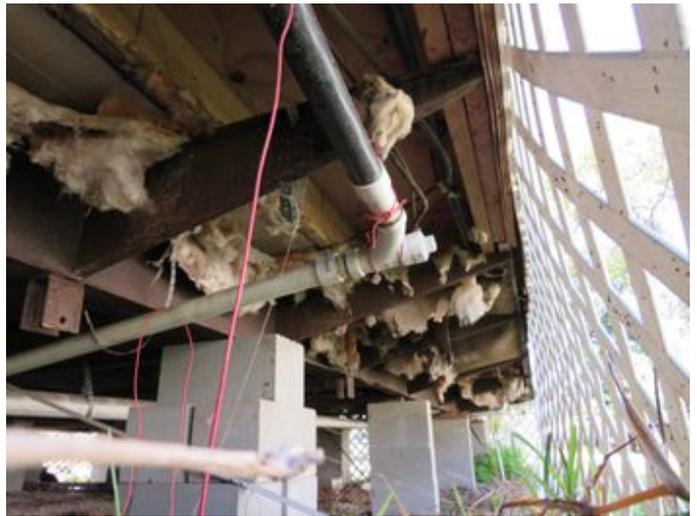
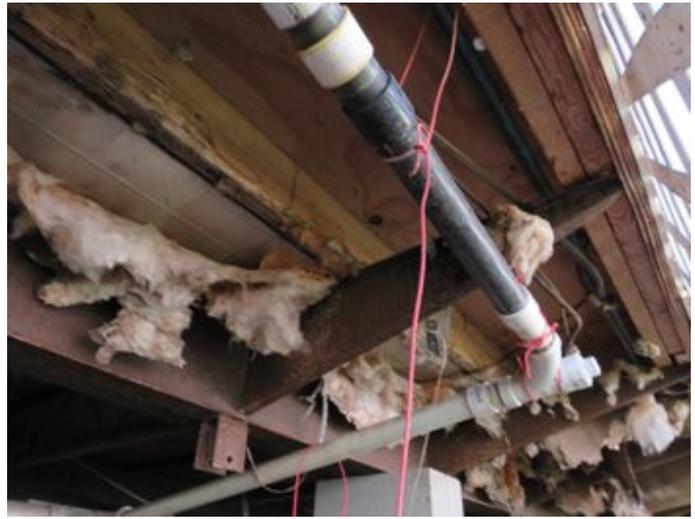
4.1 · CONDITION

Indicated (broken /missing vapor barrier)area needs to be repaired

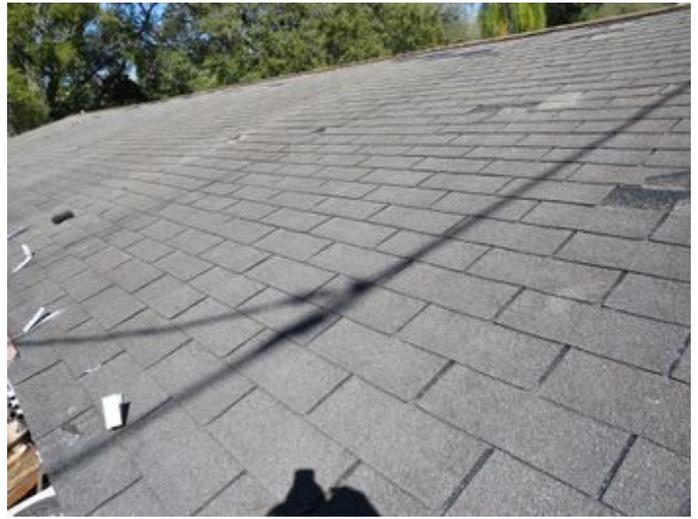
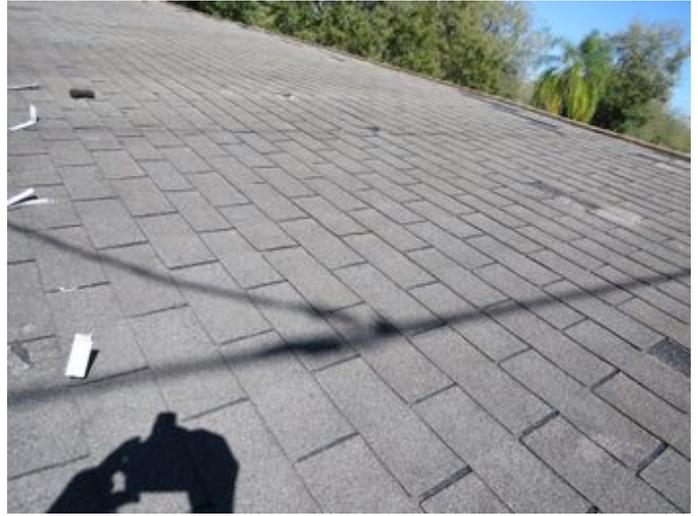
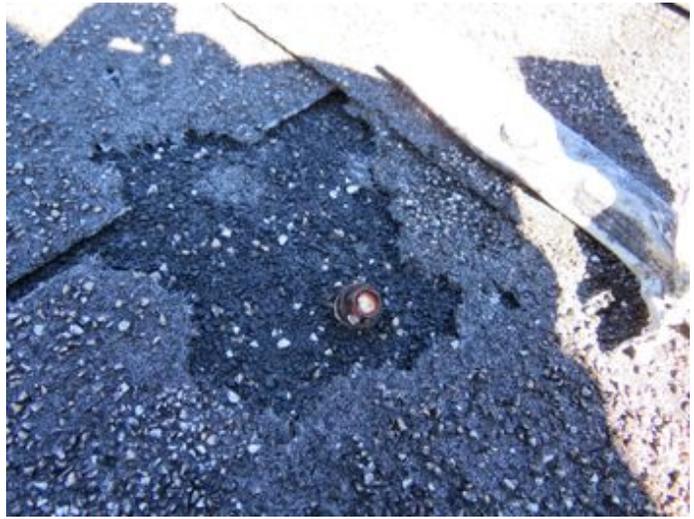
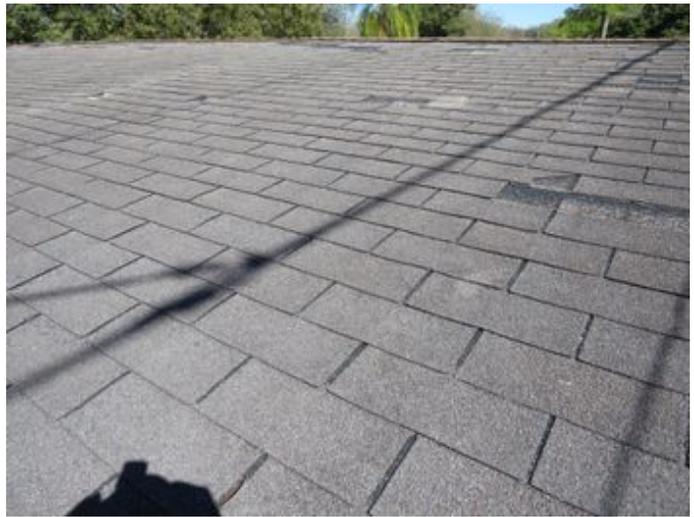
7.2 · GENERAL COMMENTS

Overall condition of the roof appears to be in unsatisfactory (excessive granular loss, brittleness, missing shingles) condition. Replacement/further evaluation recommended

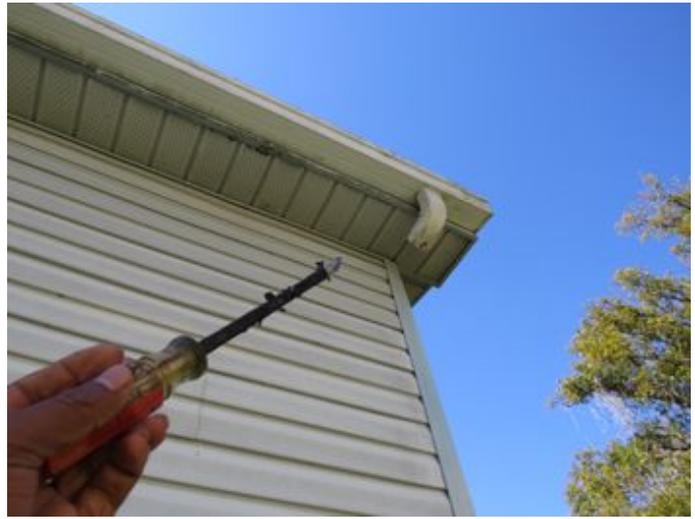
7.3 · CONDITION

Gutter is missing in the indicated area. Repair recommended

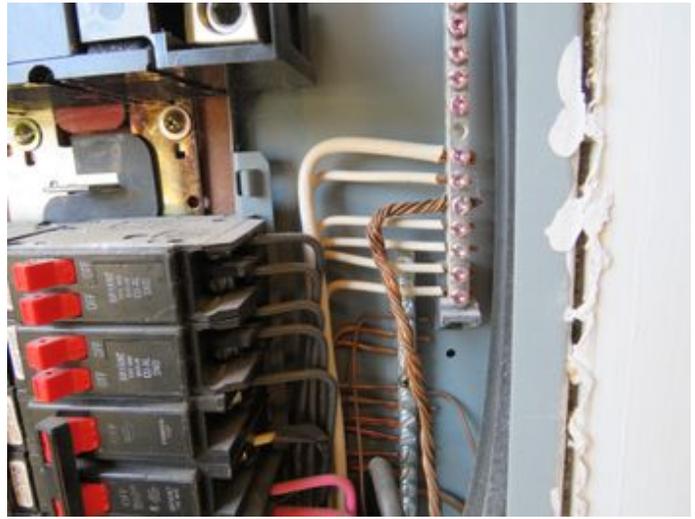
8.4 · WIRING TYPE

Copper and found in satisfactory condition

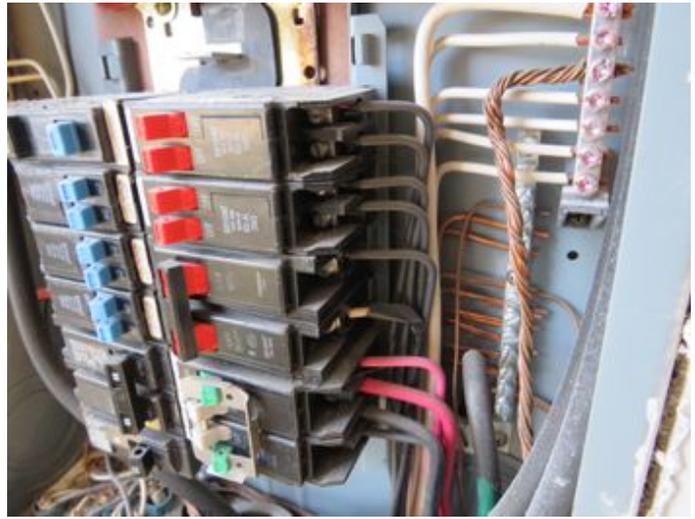
8.5 · CIRCUIT BREAKERS

Overall condition of the circuit breakers found in satisfactory condition during the inspection process.

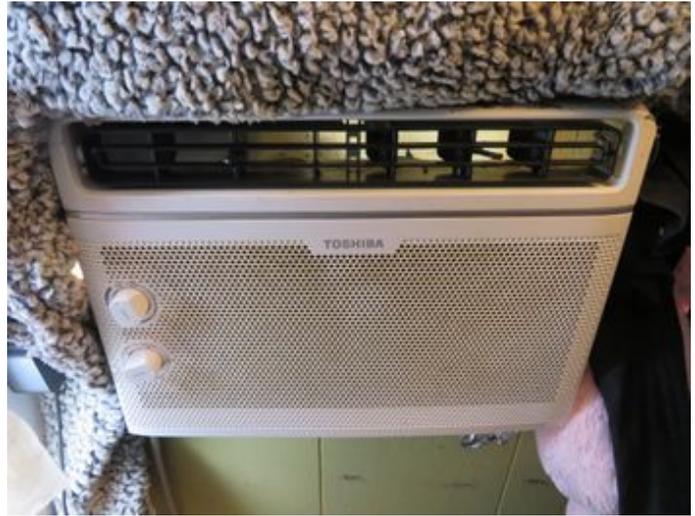
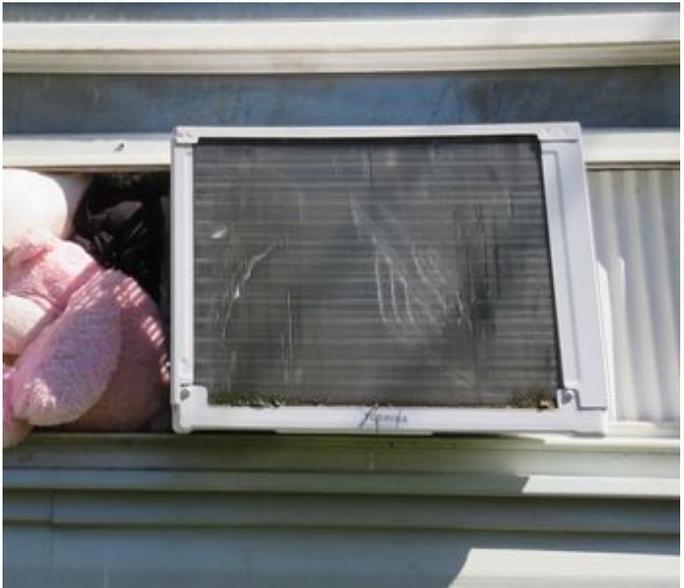
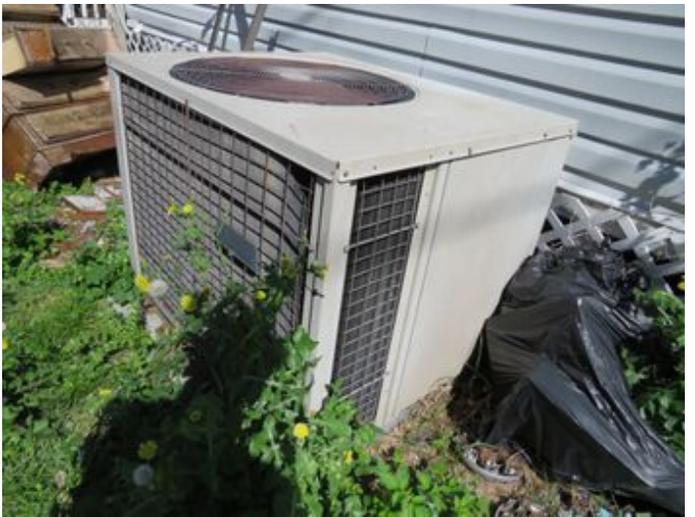
9.1 · CONDITION

Window units found in satisfactory condition during the inspection process. However, one of the unused package units observed on the premise. Further evaluation recommended.

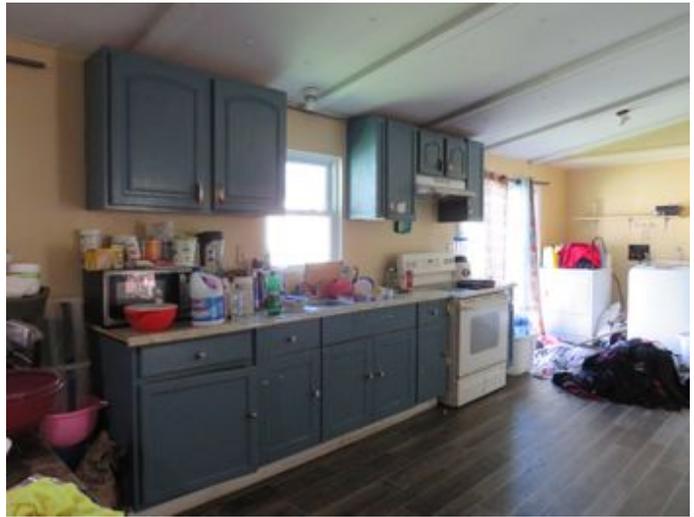
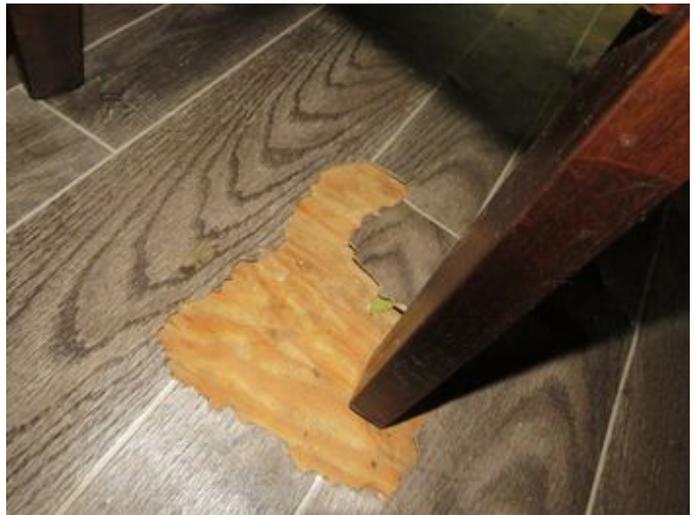
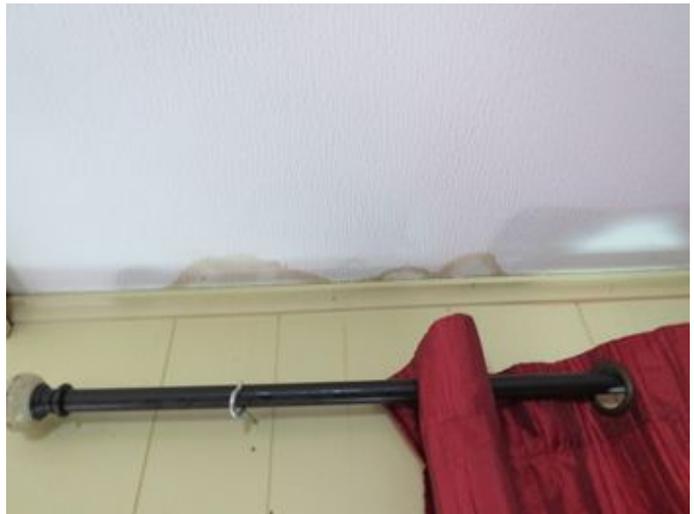
10.1 · WALLS FLOOR & CEILING

The walls and ceiling are in acceptable condition. However indicated area (floor) observed cracks and further evaluation/repair recommended

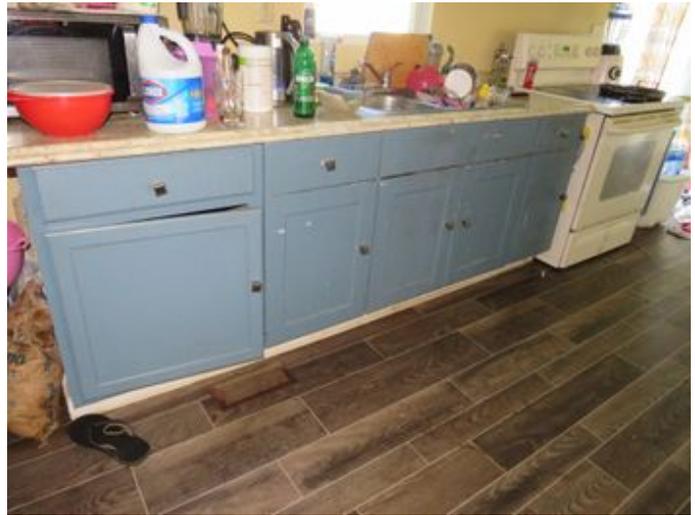
10.3 · CABINETS AND COUNTERTOPS

The cabinets are functional, and do not have any significant damage.

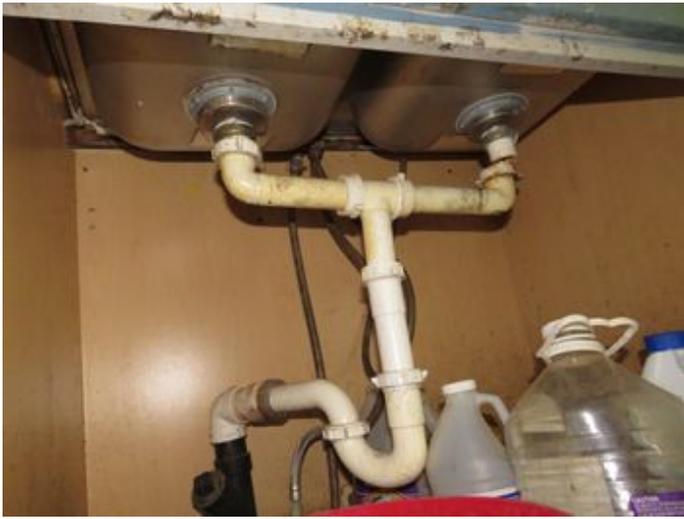
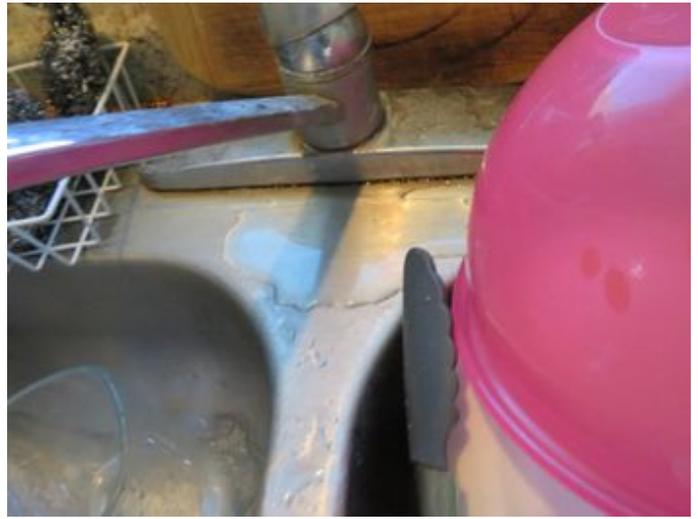
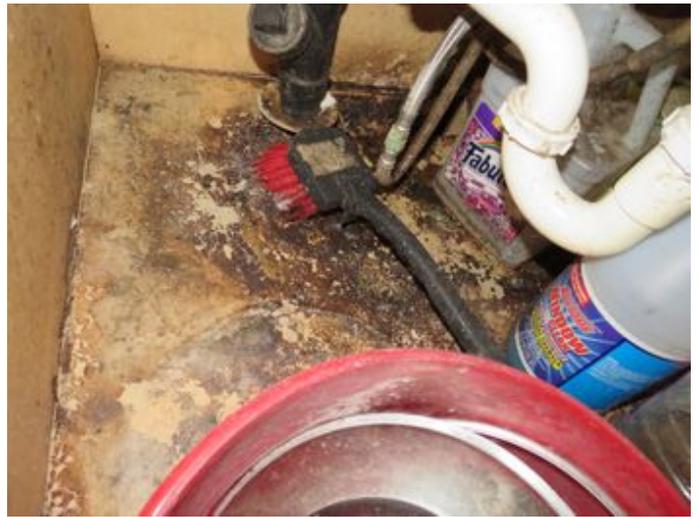
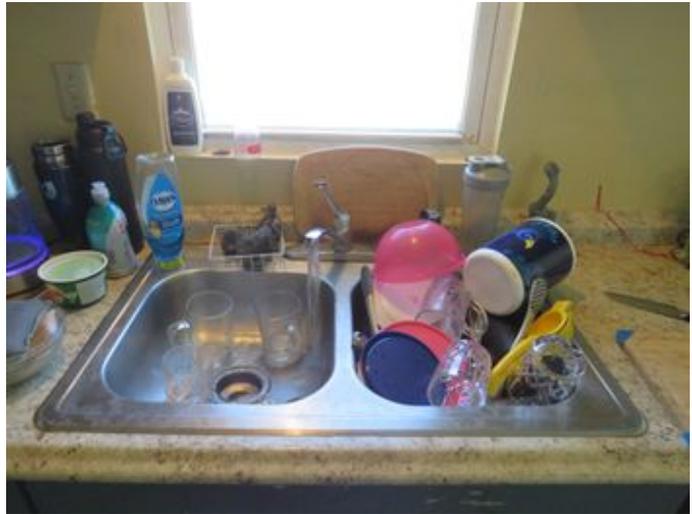
10.4 · SINK, FAUCET, TRAP & CONNECTORS.

Appears to be in satisfactory condition. However deficiencies observed (leaks on the faucet, defective spray wand, peeling off pieces from underneath the sink) in the indicated area . Repair recommended

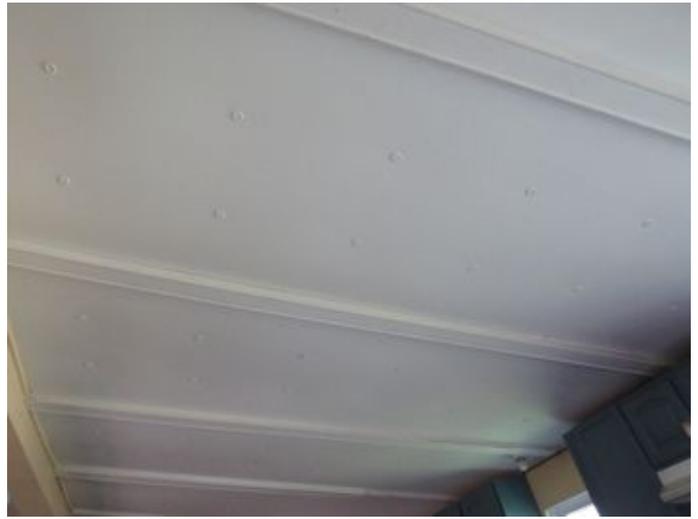
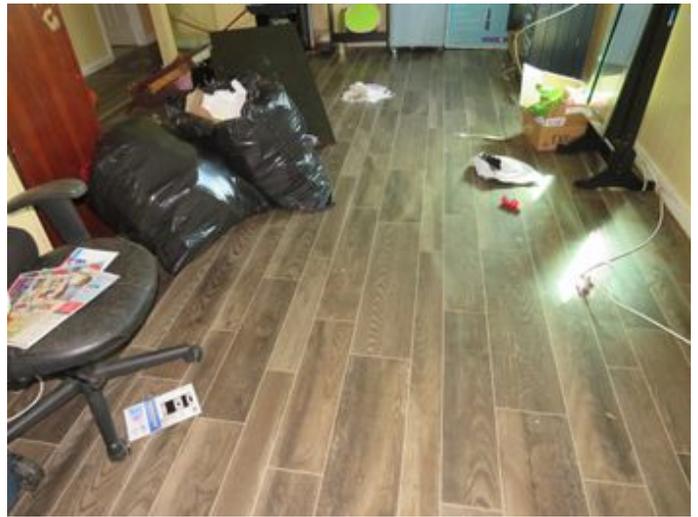
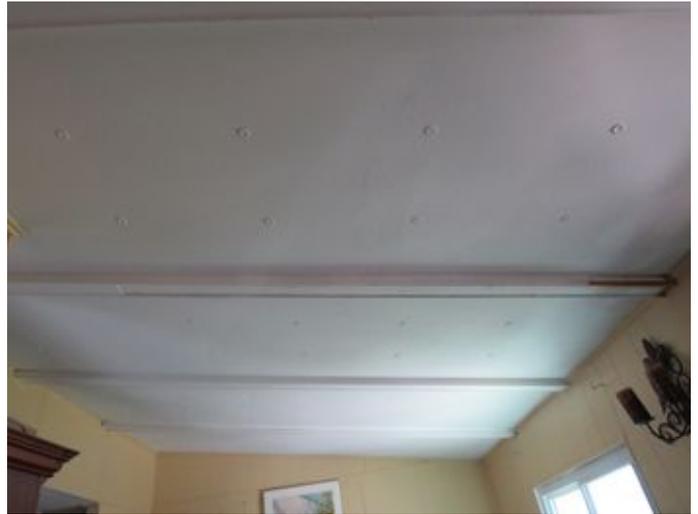
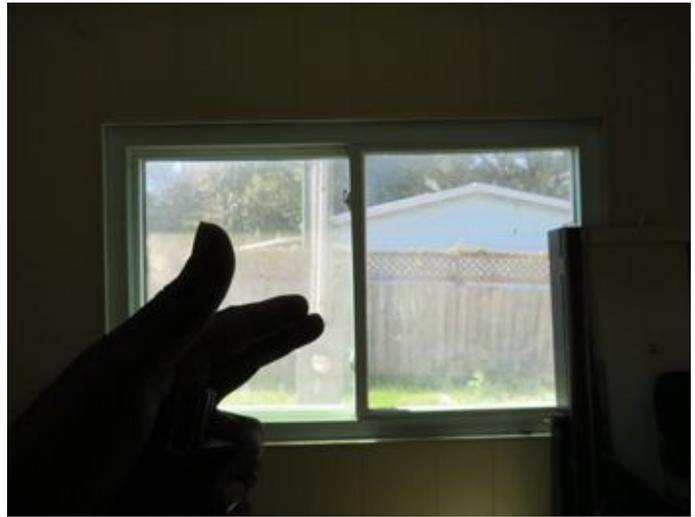
11.1 · WALL, FLOOR & CEILING

Overall condition of the living room is unsatisfactory. Indicated areas observed damages. Repair and further evaluation recommended

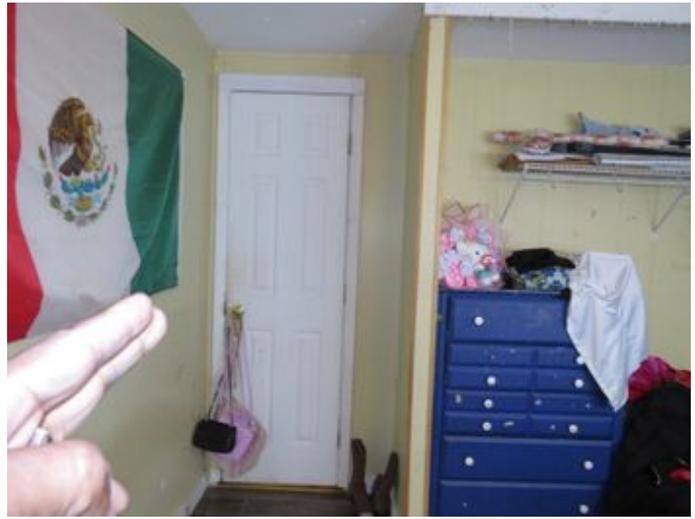
12.1 · DOOR & WINDOWS

Door found in unsatisfactory condition. And windows sills observed past water stains.

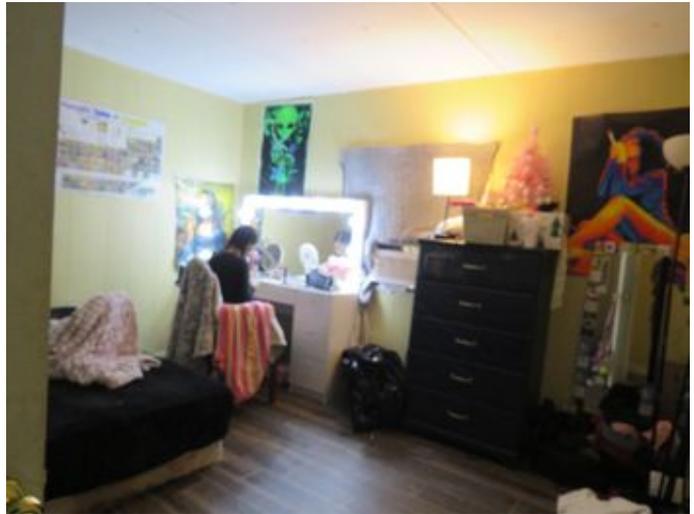
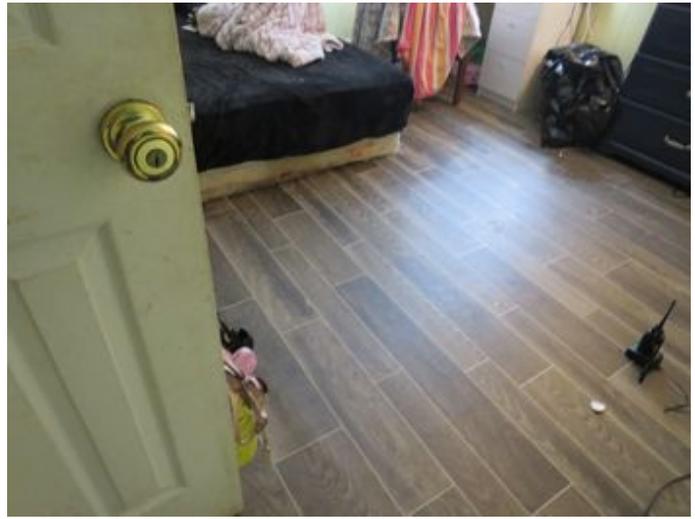
12.3 · WALLS, FLOOR & CEILING

Patch observed on the wall. Repair required

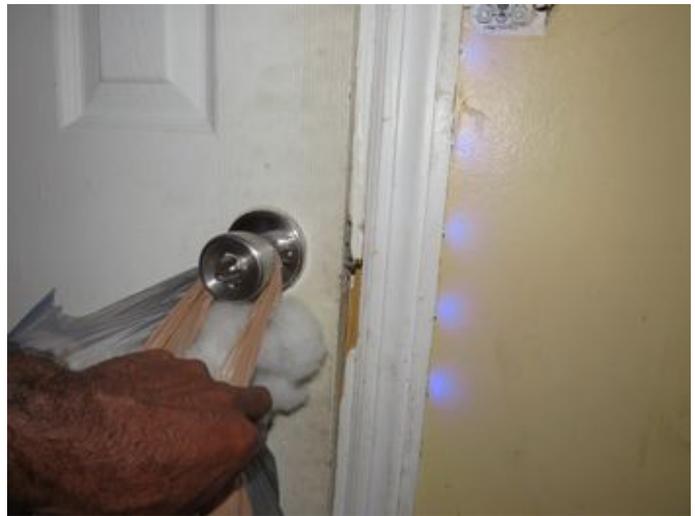
13.1 · DOOR & WINDOWS

Door found in unsatisfactory condition. And windows are difficult to operate. Repair/replacement required

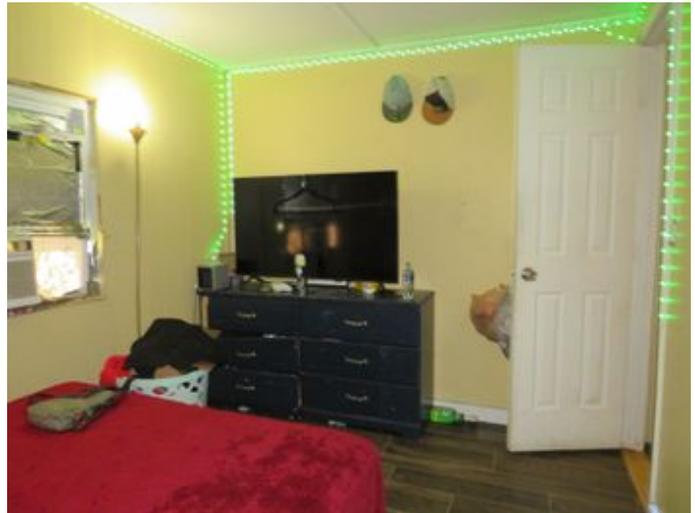
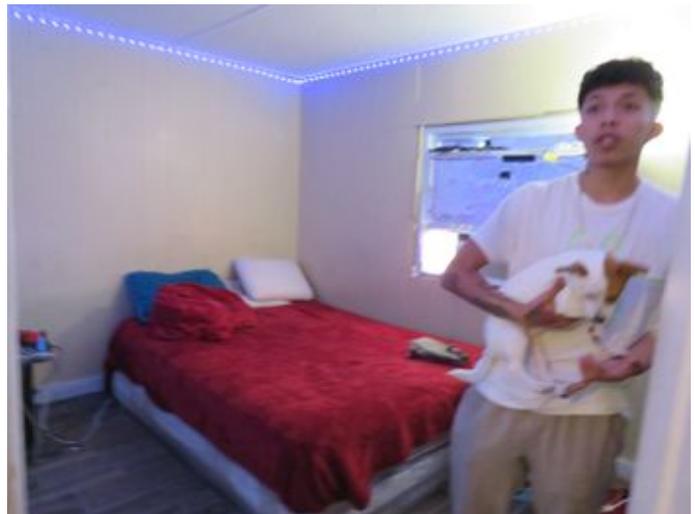
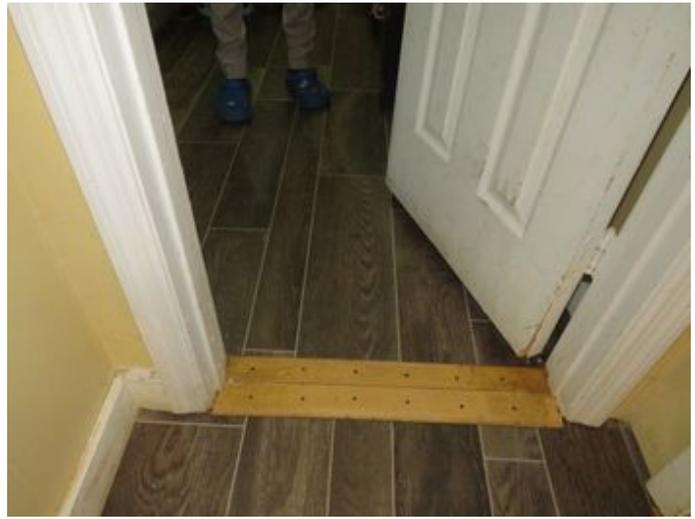
13.3 · WALLS, FLOOR & CEILING

Overall condition of the wall floor and ceiling found in satisfactory condition during the inspection process

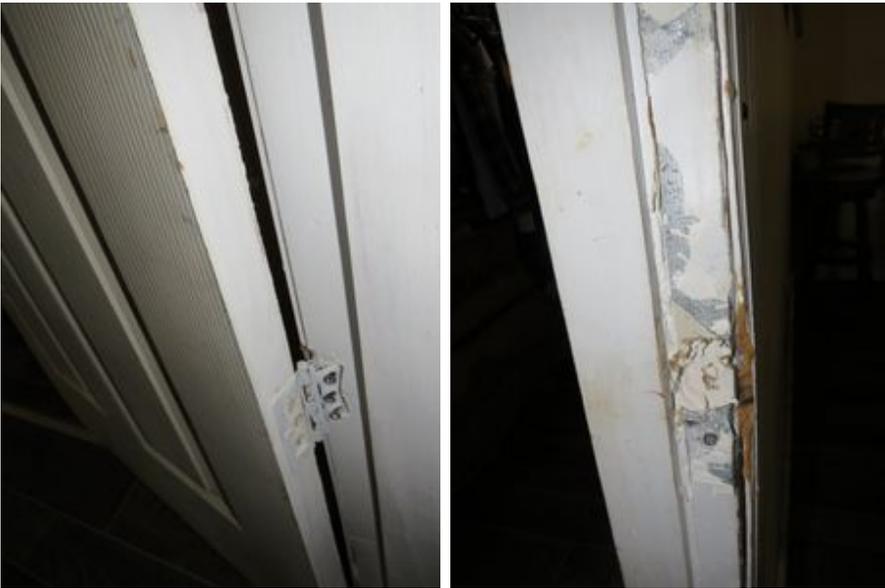
14.1 · DOOR & WINDOWS

Door observed deficiencies. Repair recommended

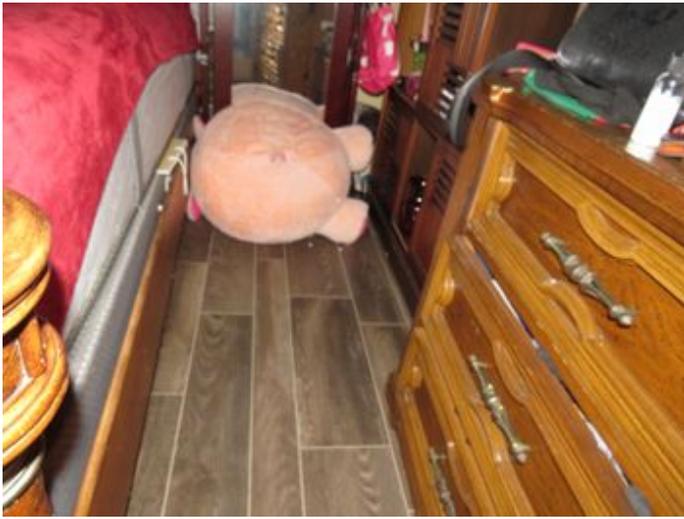
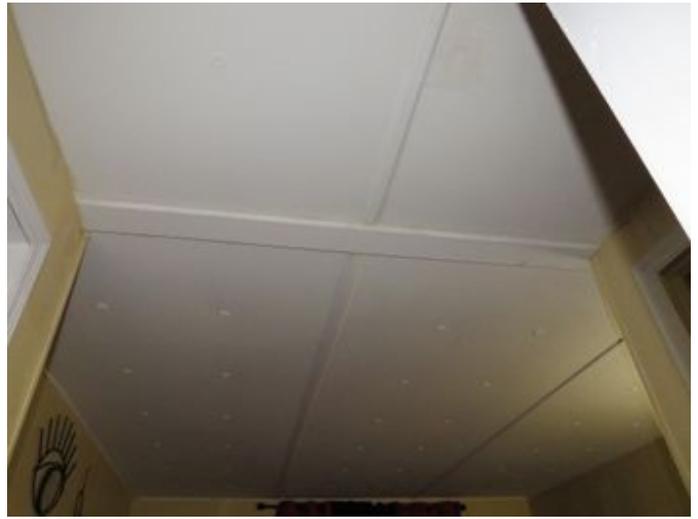
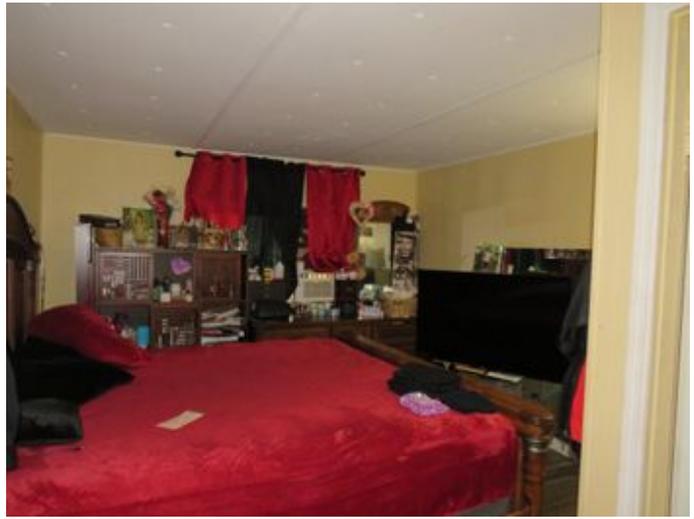
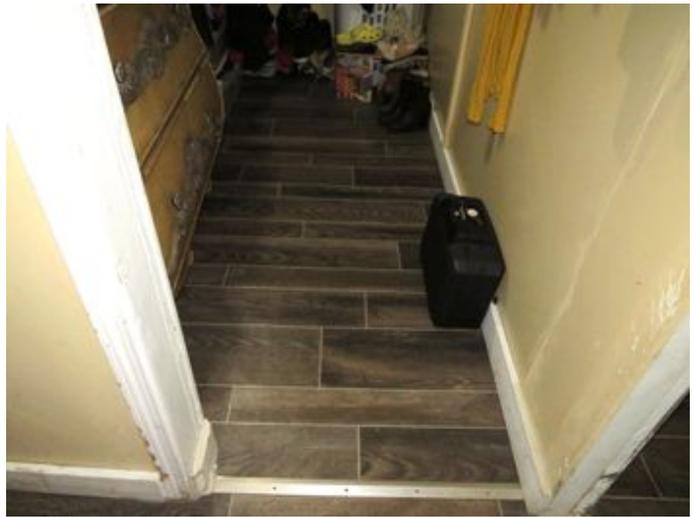
14.3 · WALLS, FLOOR & CEILING

Indicated area needs to be repaired (transition strip missing by the door on the floor, cracks on tiles). Repair required

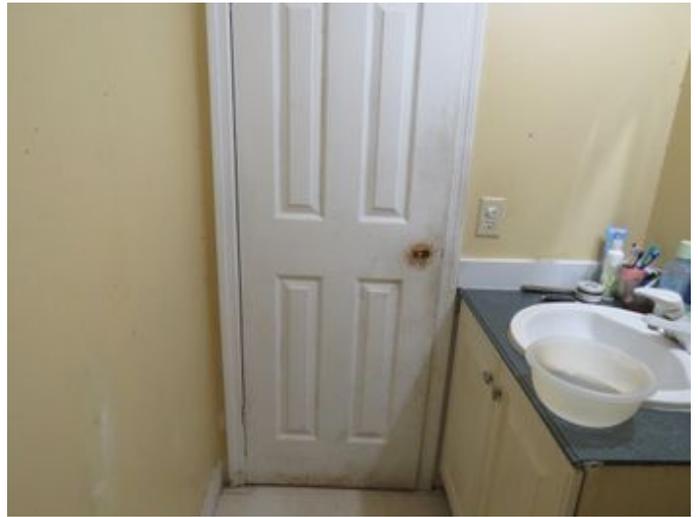
15.1 · DOORS

Door found in unsatisfactory condition. Repair/replacement required

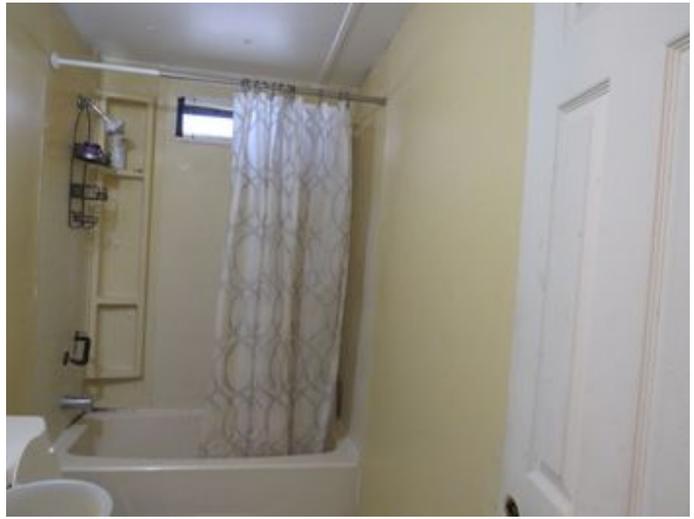
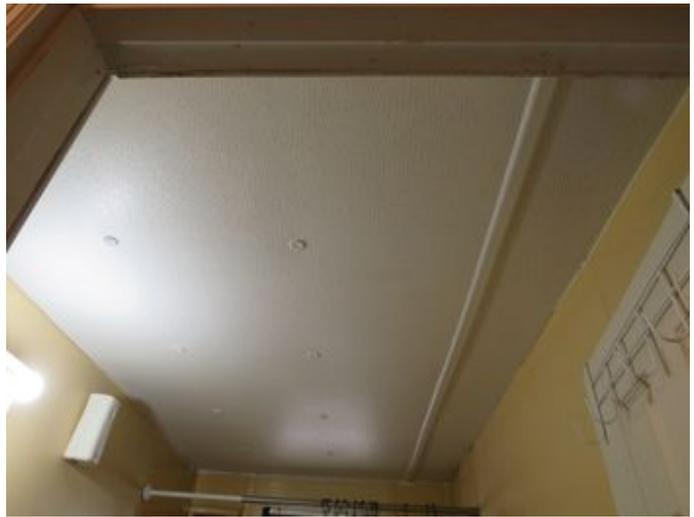
15.2 · WALLS, FLOOR & CEILING

Overall condition of the walls, floor and ceiling found in Satisfactory during inspection process

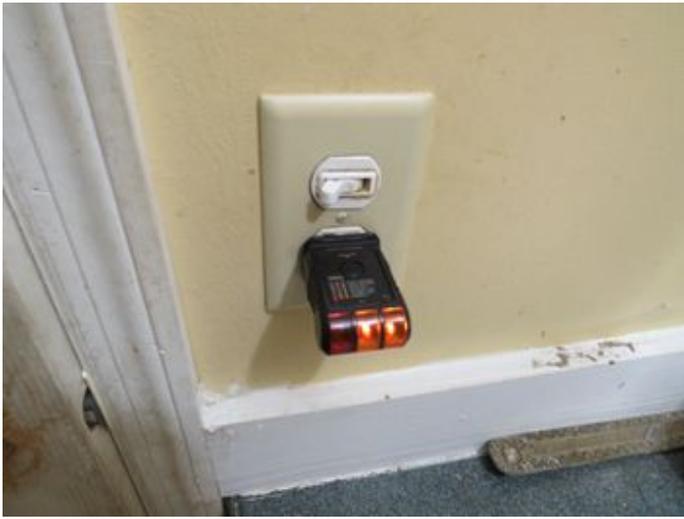
15.4 · LIGHTS AND OUTLETS

Satisfactory condition

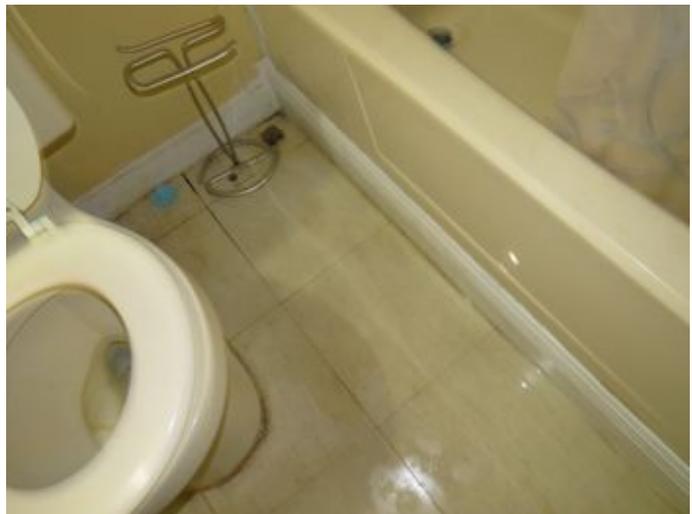
15.7 · TOILET & CONNECTORS

Toilet is broken, leaks at the bottom. Repair required
