[REDACTED]

Zephyrhills, FL, 33542

February 20th, 2024

Inspected *by* Md Uddin

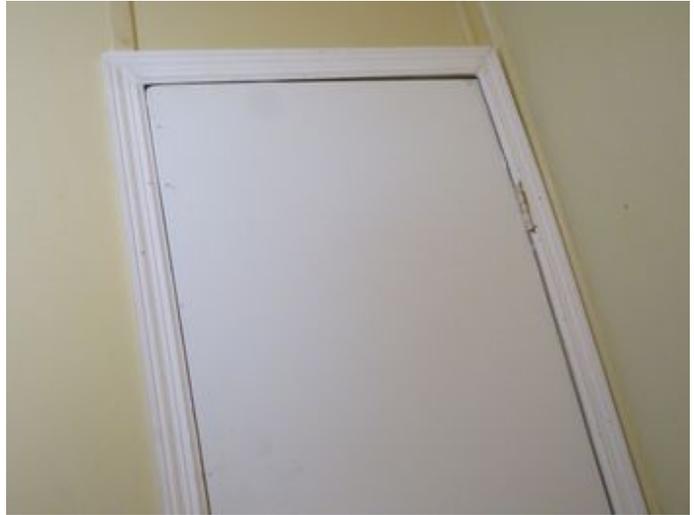
15.8 · DOORS

The door is damaged and should be replaced.

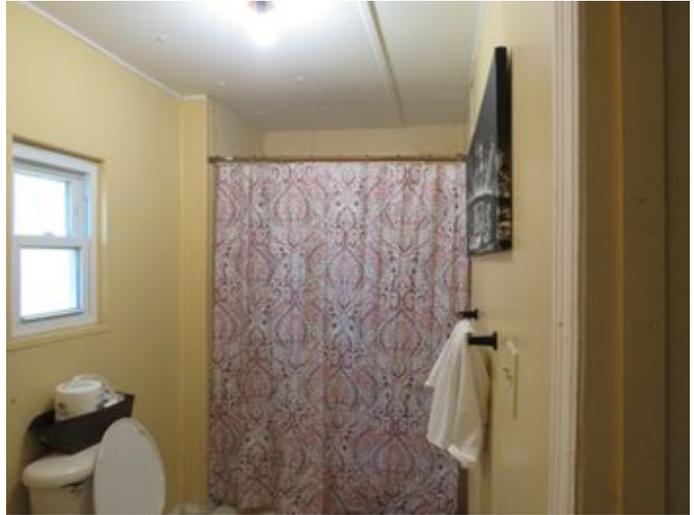
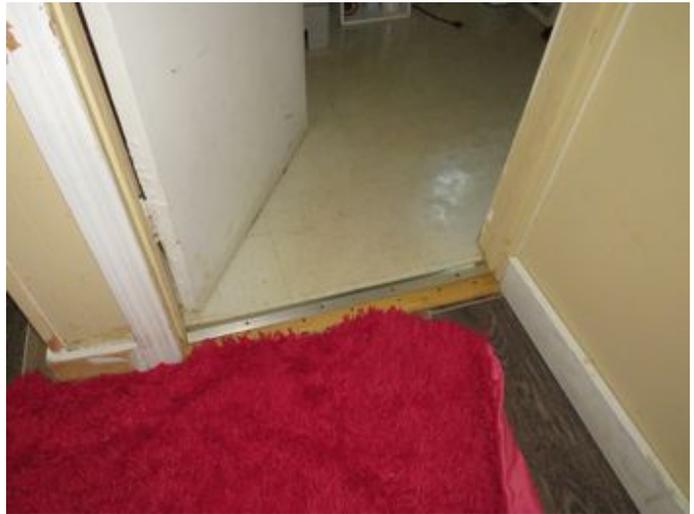
15.9 · WALLS, FLOOR & CEILING

Walls, floor and ceiling appears to be satisfactory. However mold suspected in the indicated area(closet). Further evaluation recommended

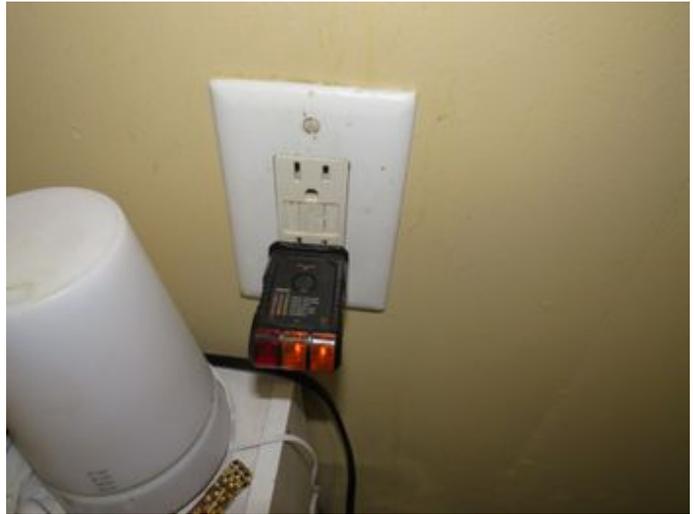
15.11 · LIGHTS AND OUTLETS

Satisfactory condition

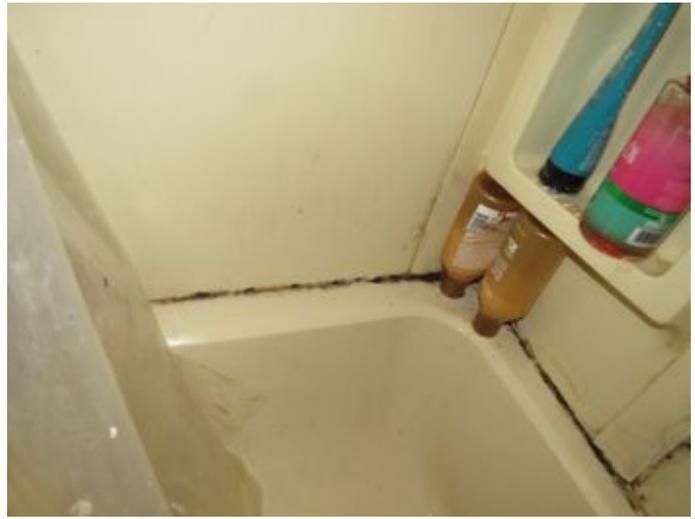
15.13 · SHOWER

The tub/shower drains too slowly, caulk missing in several areas and should be serviced, because such blockages can progress beyond the drain trap and involve the main waste line.
